PHOTOGRAPHIC DOCUMENTATION

Investigation Date: 07/23/2016
Investigation No. NA

Facility Name: Lane Plating

Investigator: Eric Leigh (on behalf of Dorothy Lewis)

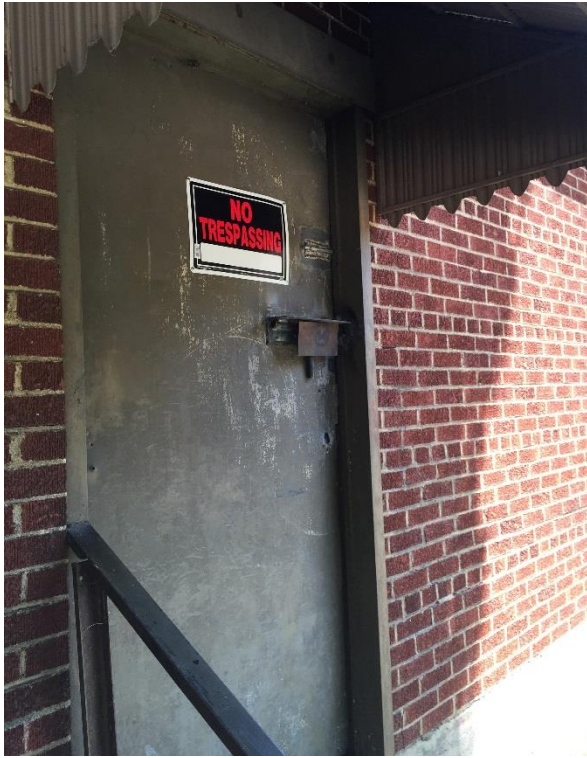
Photograph #1

Comments: Repaired side access door lock. The locking mechanism consists of a large sliding bolt lock that was welded to the door and secured with a lock guard plate.

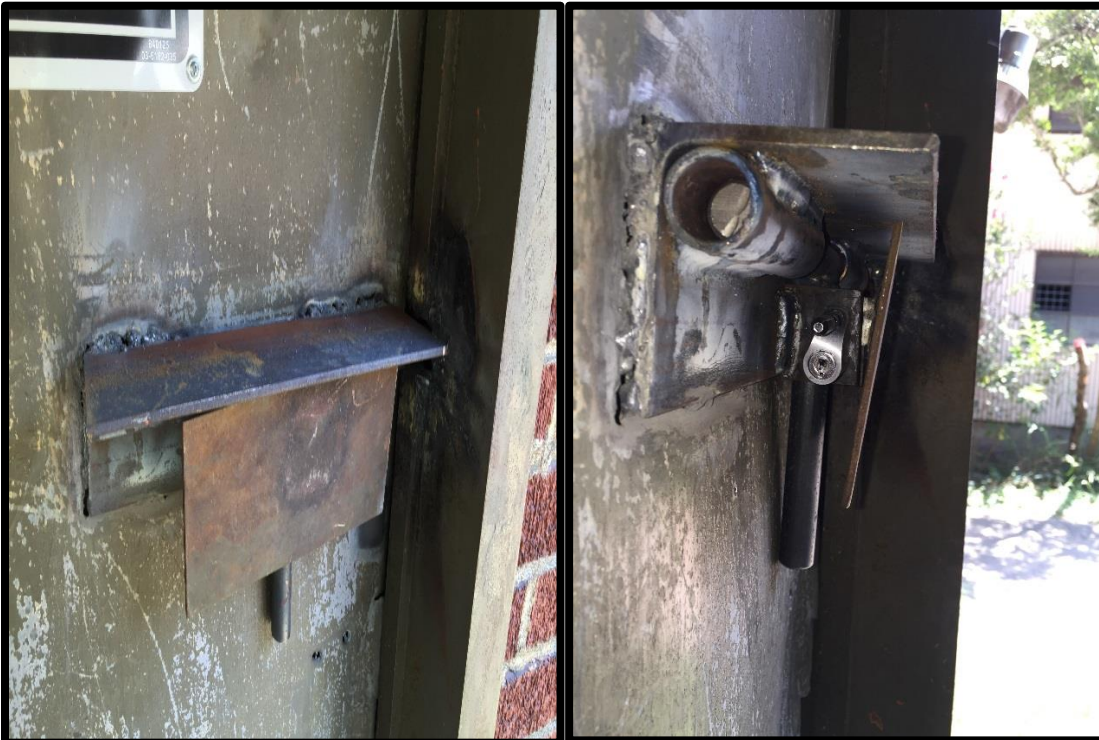
Photograph #2

Comments: Repaired side access door lock. The locking mechanism consists of a large sliding bolt lock that was welded to the door and secured with a lock guard plate.

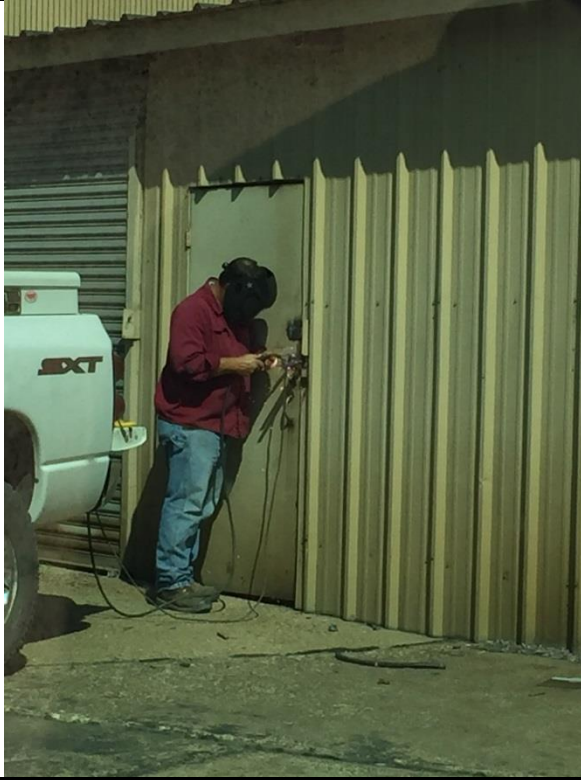
Photograph #3

Comments: Black Oxide Room door welded shut. No access to this room now.

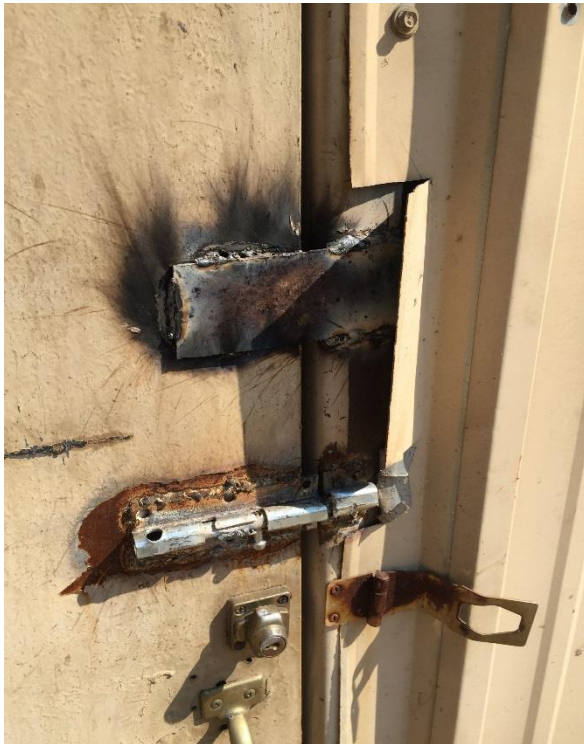
Photograph #4

Comments: Black Oxide Room door welded shut (close-up). No access to this room now.

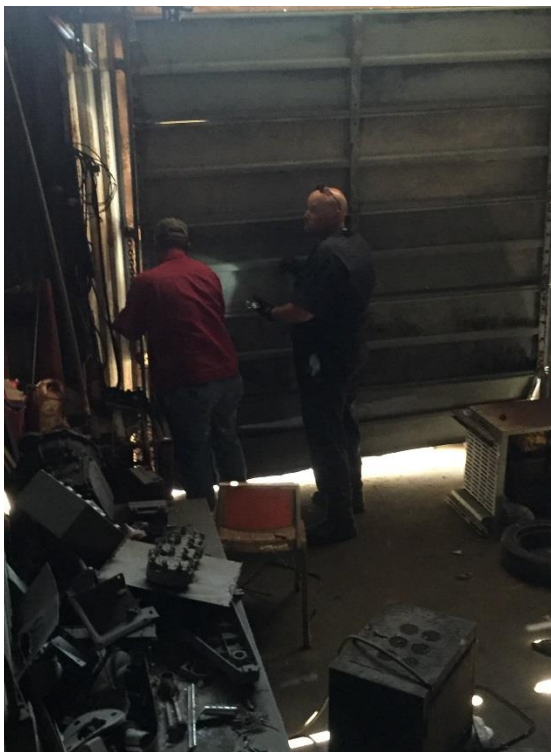
Photograph #5

Comments: Repair of roll-down Rectifier Room door (inside view).

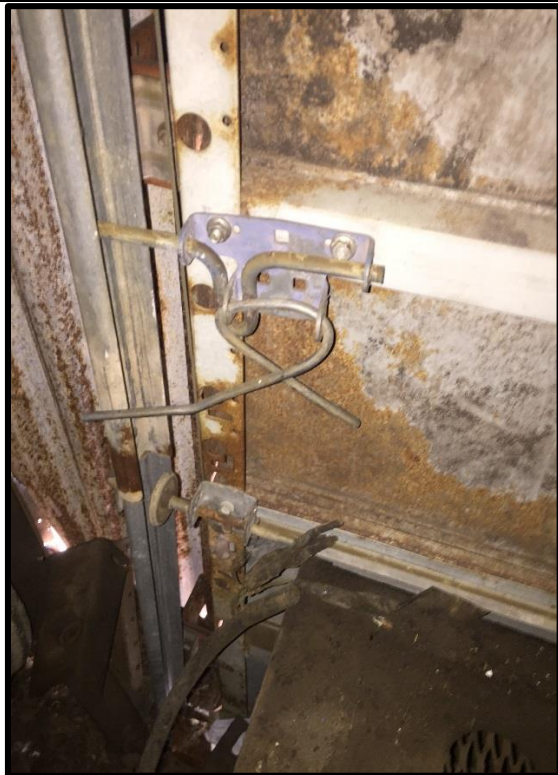
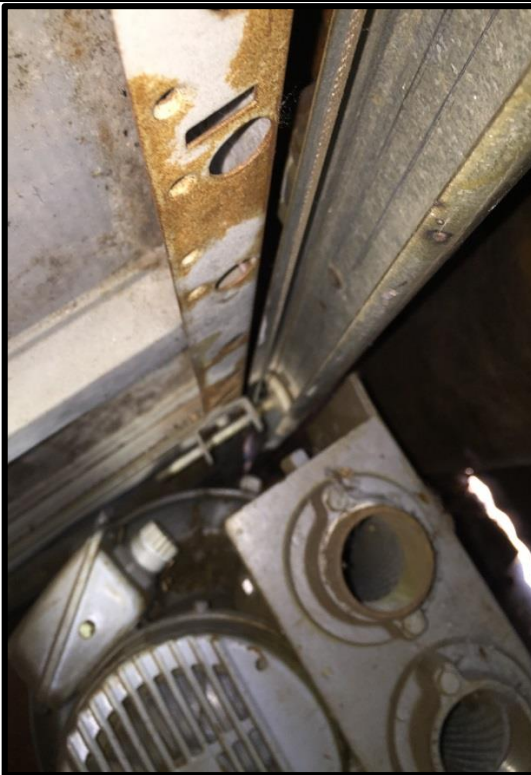
Photograph #6

Comments: Left and right sides of roll-down Rectifier Room door (close-ups) after repair. Bolts and a steel rod were inserted into the inside track system of the door.

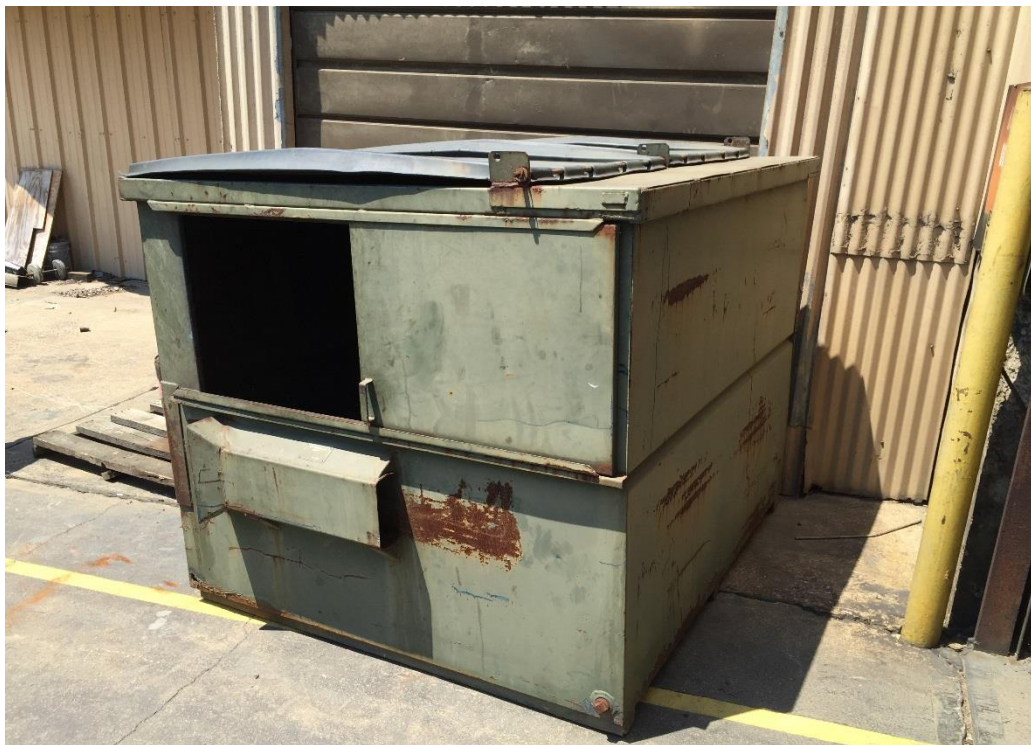
Photograph #7

Comments: Outside view of the roll-down door to the Rectifier Room after repairs. Dumpster remains outside of the door.

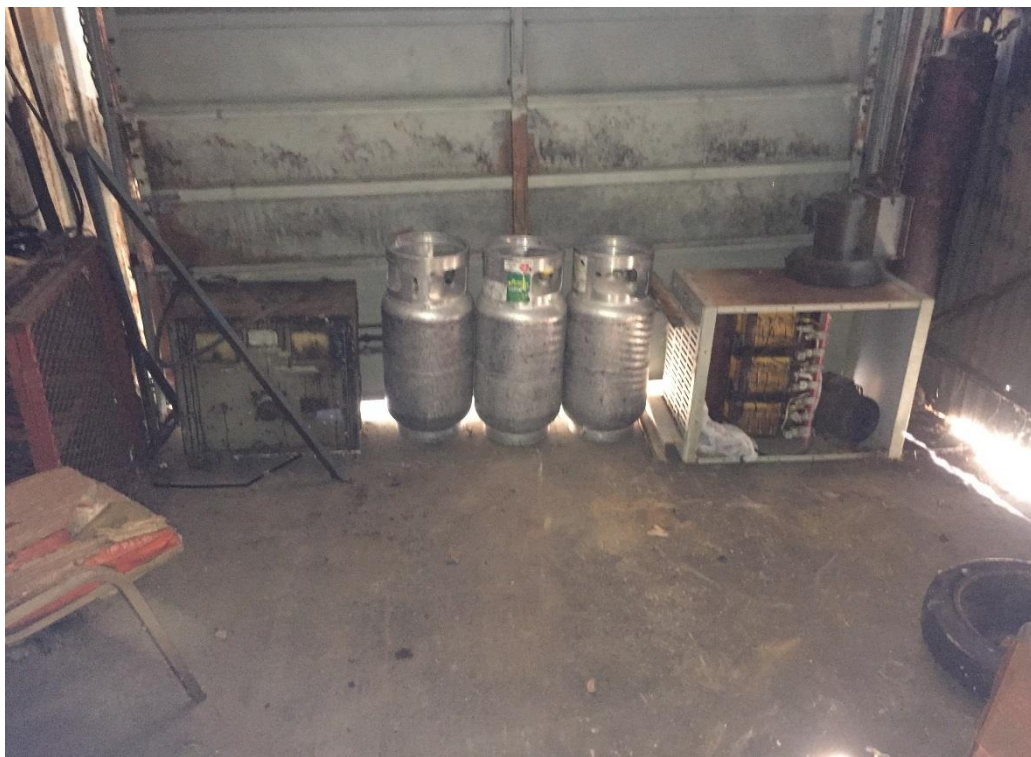
Photograph #8

Comments: Inside view of the roll-down door to the Rectifier Room after repairs.

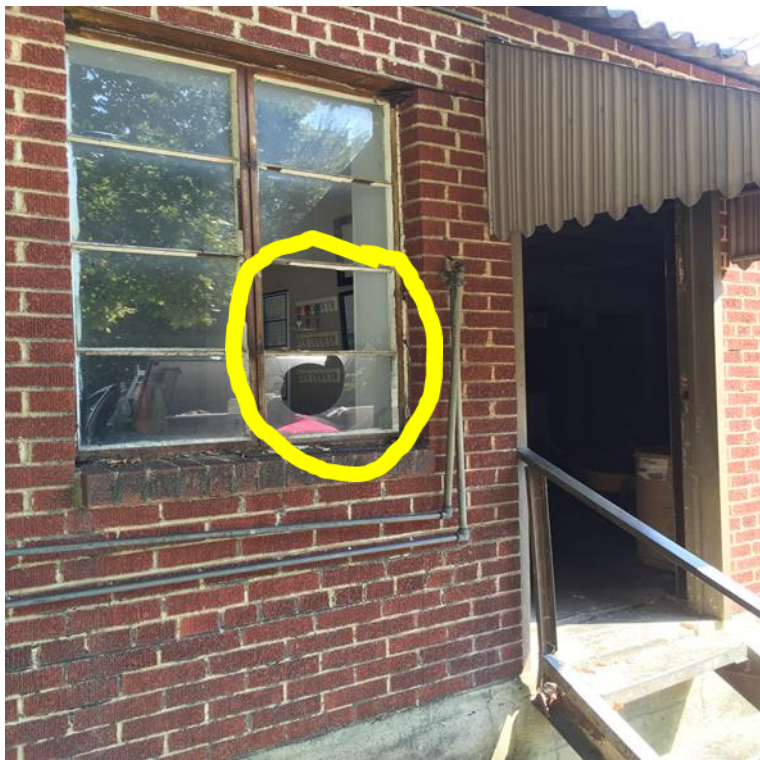
Photograph #9

Comments: Window was not repaired.

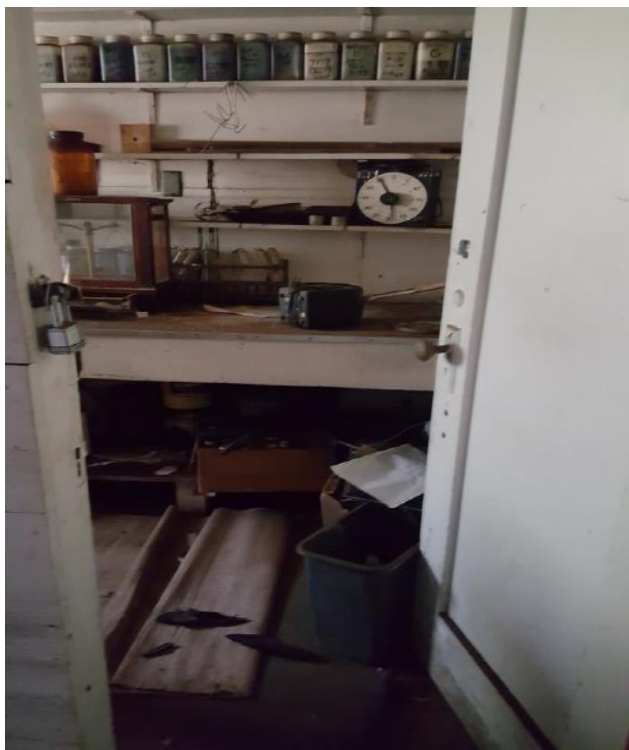
Photograph #10

Comments: Laboratory door was not repaired. SWS determined it was not feasible to repair the door.
